**Initial report on environmental impacts of unconsented
work on the River Bure at Saxthorpe**

June 2023

Initial report on unconsented work on the River Bure at Saxthorpe.

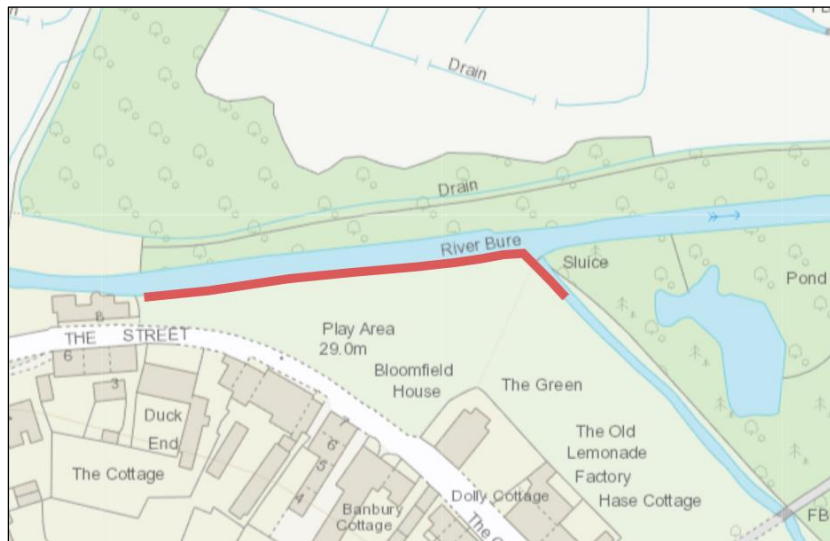
Figure 1. The extent of dredging work (red line) on the River Bure at Saxthorpe.

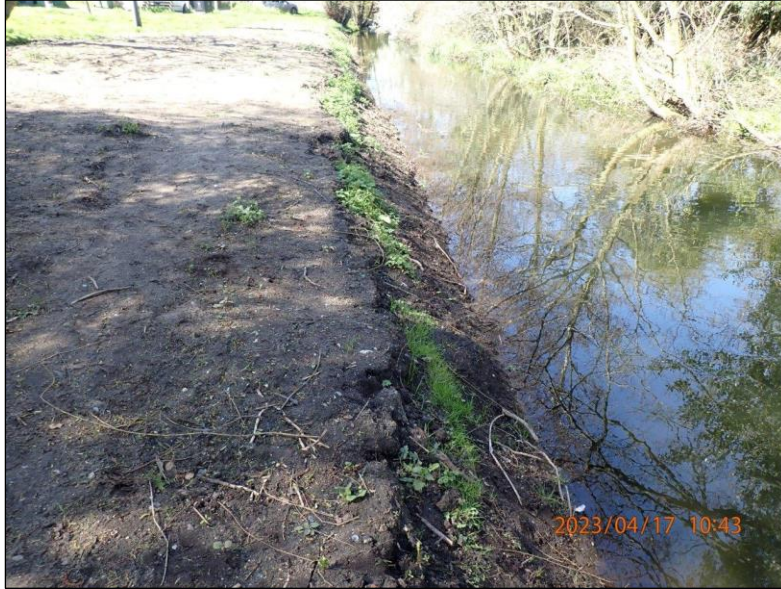
1. Silt removal from the channel and selected re-sectioning of the banks (see Photographs 1, 2, 3, 4, 5). Spoil removed from the channel has been spread in a strip approximately 5m wide adjacent to the river. The effect of this work has been to deepen and widen the river, simplifying the diversity of physical habitats and the flow and depth regime of the river. In places some of the gravel bed substrate has also been removed and can be seen mixed in with the finer sediment removed from the river (see Photographs 2,4,5,7,9). In the bypass channel, some of the natural river bank has been replaced by a hard edging of stone filled gabion baskets (Photograph 6). The bed of the first 20 metres or so of the bypass channel has been disturbed (Photographs 8 and 10), with some gravels moved to the channel edge (Photograph 9) and some deposited on the bank (Photograph 7). It is also possible that some gravel has been removed in connection with the construction of the gabion basket edging.

Photograph 1. (Exhibit AM01A – P4170012) General view of affected reach showing spread spoil and reprofiled river bank.

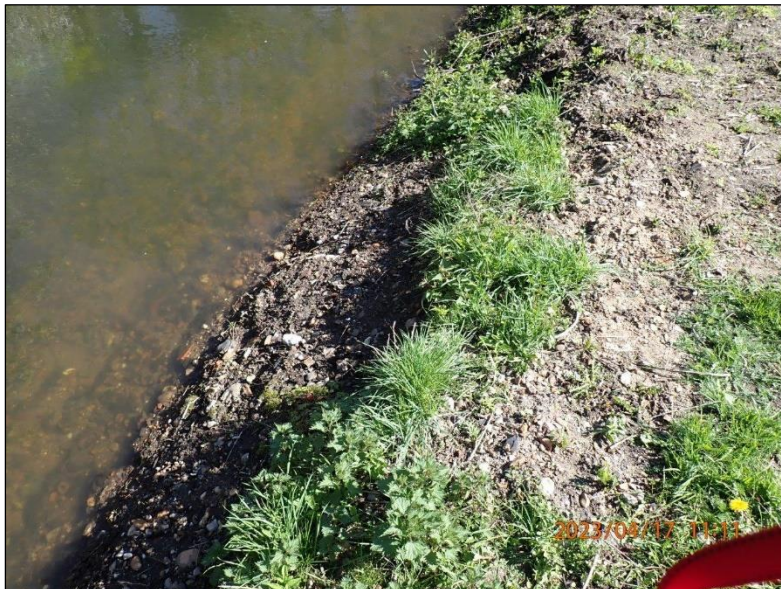
Photograph 2. (Exhibit AM01B-P4170024) Reprofiled bank edge and gravel deposited on bank top. Upstream end of reach.

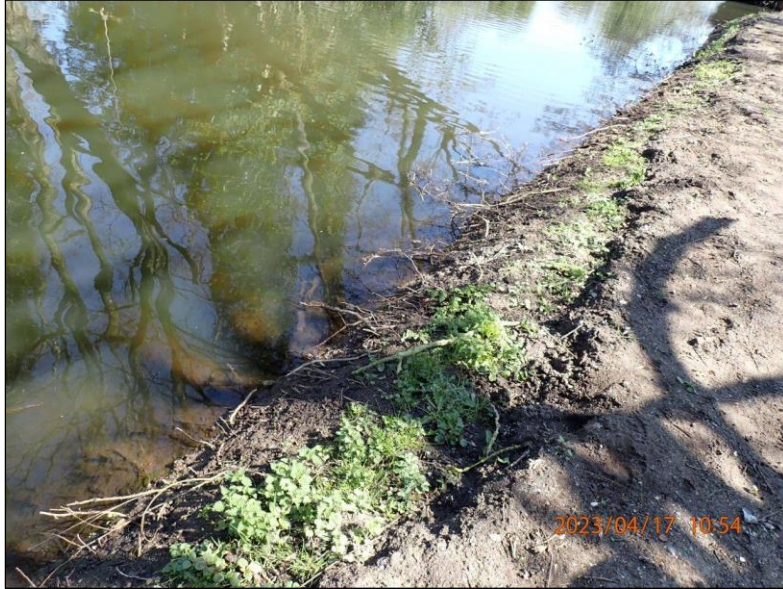
2. Removal of in-channel (emergent and submerged) and marginal vegetation. The fringing marginal vegetation of reed has been removed from the channel. Photograph 3 shows reed rhizomes which have been cut through where the bank has been reprofiled, and Photograph 4 shows stems of removed vegetation amongst the spread spoil. This will have impoverished the habitat for water vole and a range of other animal and plant species including brown trout.

Photograph 3. (Exhibit AM01C-P4170016) Reprofiled bank edge showing cut through reed rhizomes/plant roots.

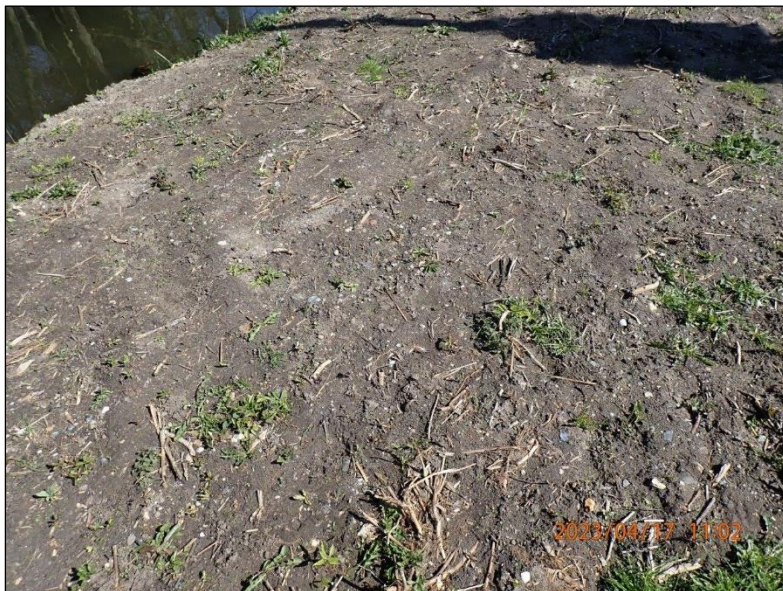
Photograph 4. (Exhibit AM01D-P4170019) Gravel and silt spread on bank adjacent to river.

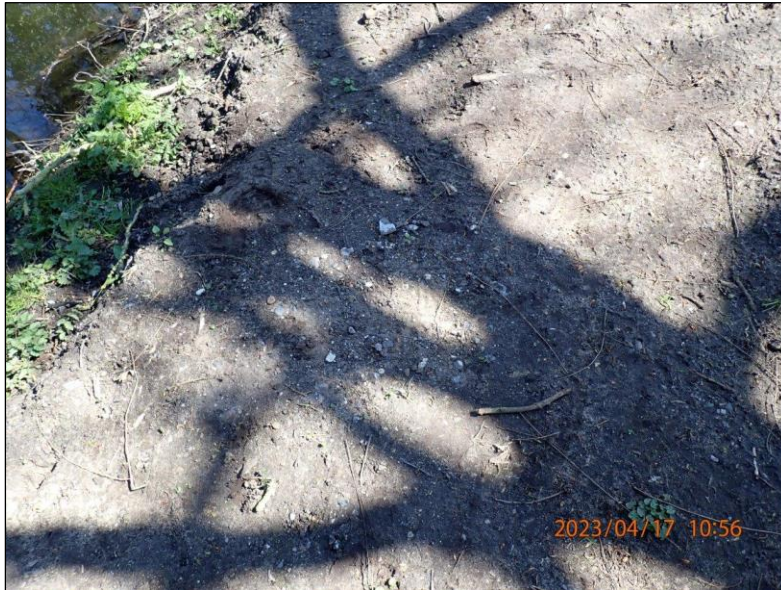
Photograph 5. (Exhibit AM01E-P4170017) Gravel intermixed with silt and sand on river bank.

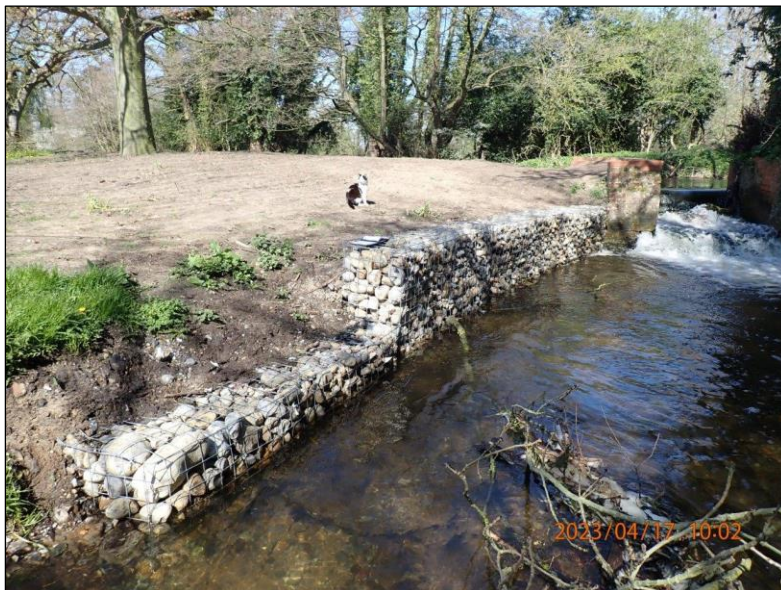
Photograph 6. (Exhibit AM01F-P4170001) Gabion baskets installed along right bank of mill bypass channel.

2. Measures that could be implemented to improve the ecology of the river and mitigate for the loss of habitat due to gabion basked installation include the installation of woody material features within the channel and riparian tree planting. These measures will also help mitigate/compensate for the loss of natural bank caused by the construction of the gabion basket revetment along part of the bypass channel. Further information on these measures is given below.

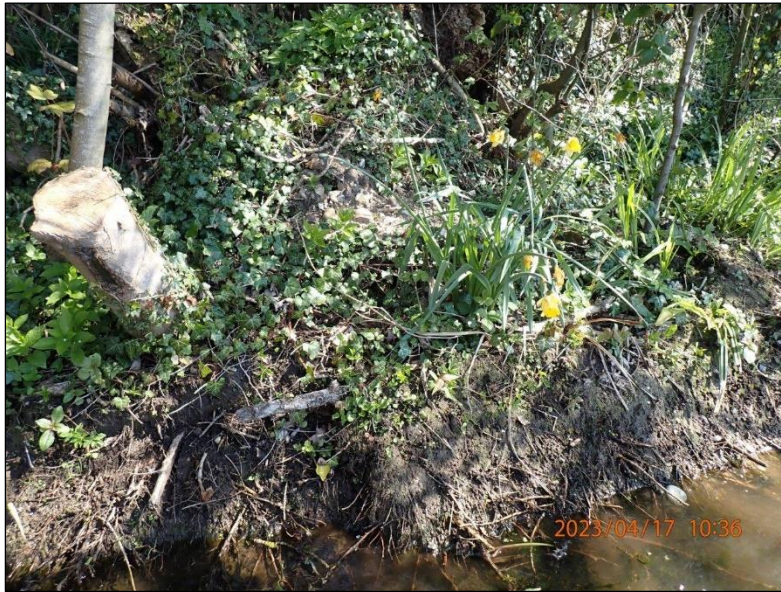
Photograph 7. (Exhibit AM01G-P4170009) Reprofiling of left bank of bypass channel and disposal of gravels (behind daffodils) on bank.

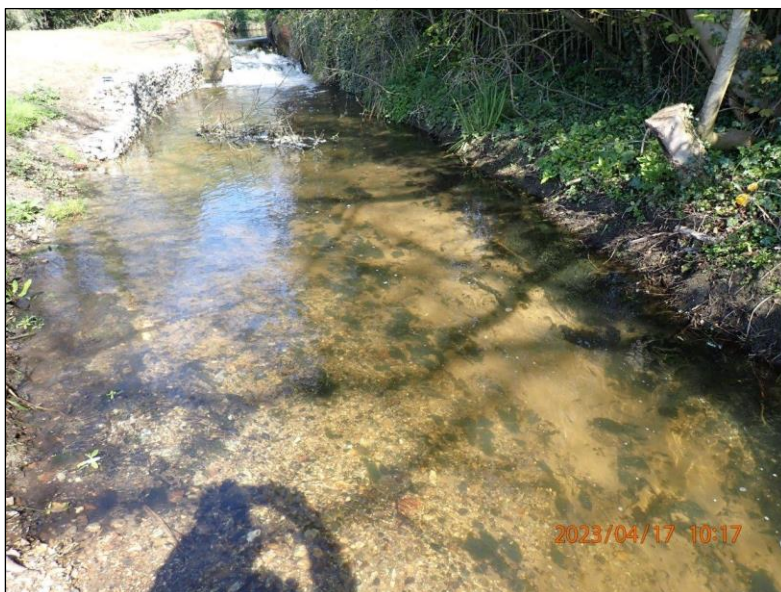
Photograph 8. (Exhibit AM01H-P4170003) Bypass channel showing reprofiled banks and disturbance to gravel bed.

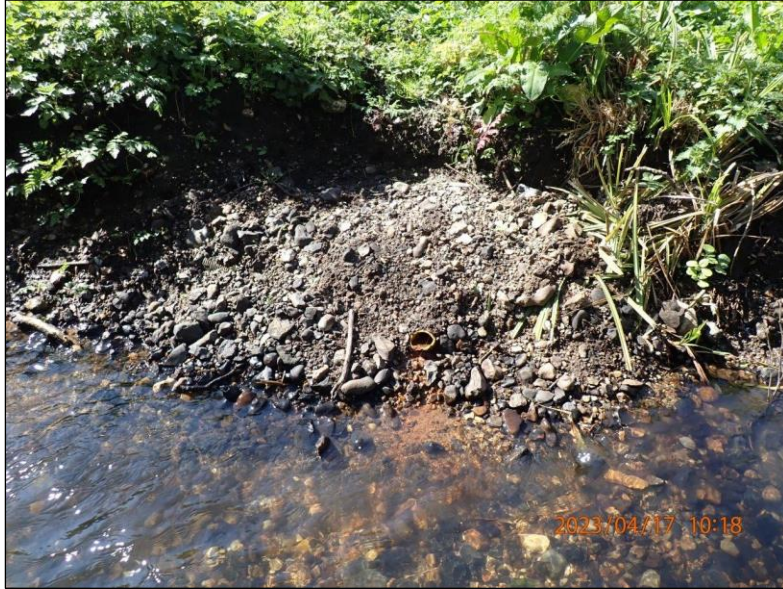
Photograph 9. (Exhibit AM01I-P4170006) Gravel deposited at edge of bypass channel.

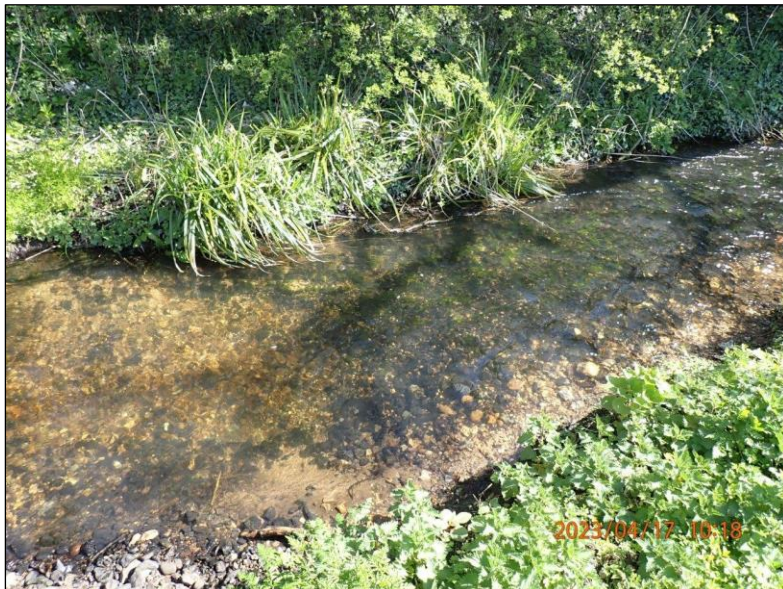
Photograph 10. (Exhibit AM01J-P4170005) Bypass channel showing disturbed gravel bed (left) and undisturbed bed (right).
